TPMS AND TIRE FIRE: A Cautionary Tale (April 2012)

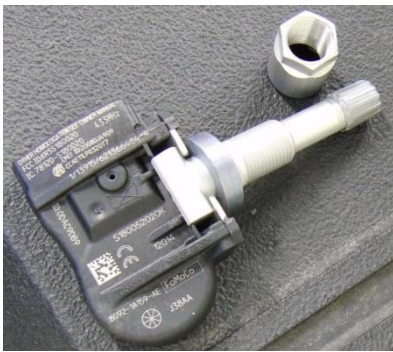
Figure 1: Exemplar TPMS unit, with stem nut removed.

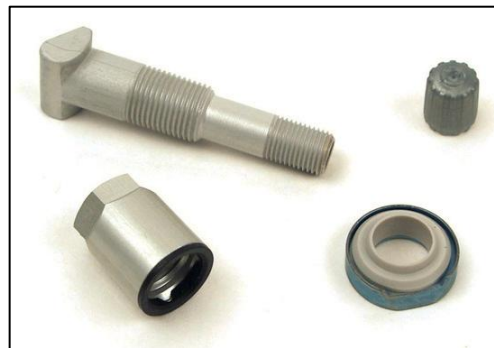
Figure 2: Typical TPMS service kit components.

The owner's manual for one such equipped vehicle instructed that "***If a tire is changed, the sensor's seal, nut, and valve core should be replaced,***" and included the following caution:

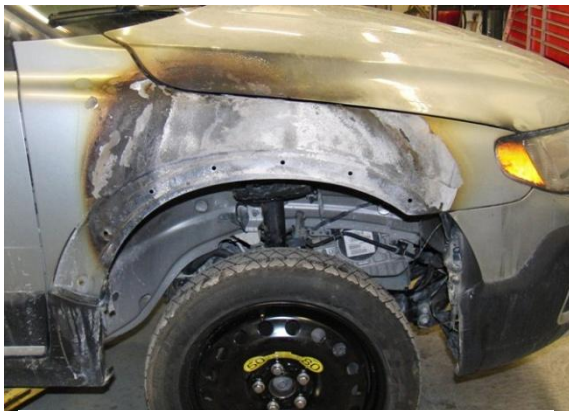
The front right fender burn pattern was consistent with the tire having burned in place while stopped, as shown in Figure 3. The fire was successfully extinguished and the mini-spare was mounted on the front right wheel position allowing the car to be driven

Figure 3: Burn pattern on fender.

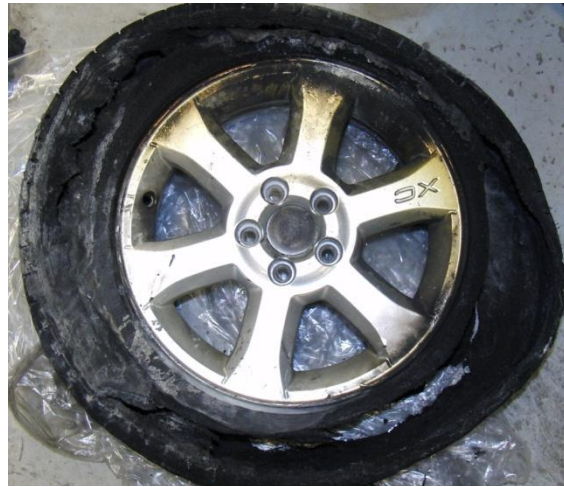
around the lot and into the service bay. The newly installed but now damaged tire is shown in Figure 4, still mounted to the wheel. Taking the valve stem hole as 12-o'clock, the tire outer sidewall was still intact between about 10-o'clock and 12-o'clock. The inner sidewall had a somewhat longer section still intact. In these areas, the sidewall showed both directional rubber tearing and grinding which had obliterated portions of the raised lettering. This damage is consistent with having been driven at severely low or zero air pressure. The TPMS unit was missing completely. The aluminum wheel displayed no slumping or heat deformation which would be expected to completely destroy the TPMS unit or allow it to separate from the wheel.

Figure 4: Damaged wheel and tire.

The missing TPMS unit was not located in an area where fire could have melted the metallic components. The wheel surface near the valve stem hole was sooted. This indicates that the TPMS sensor was not lost simply as a result of the fire, but rather came out for other reasons, and was not in place during at least most of the conflagration.

A cracked stem nut will eventually cease to retain the valve stem and the attached TPMS unit, allowing an air leak. A completely fractured nut will eventually fall off. The TPMS sensor would then be loose inside the wheel. The best explanation for the front right TPMS unit missing now is that it fell out of the damaged wheel either while driving after it came out, or during recovery. The car lived in northern New England, where road-salt is common in winter, which may have played a role in this event.

Protracted operation at low air pressure, most likely in the presence of the dashboard warning, allowed the tire to overheat enough to ignite the internal components. This conflagration erupted once the car was stopped.

The “take-away” from this story is that TPMS sensors should be inspected and serviced as recommended by the manufacturer, even though they are mostly made of metallic components. Also, low-pressure tires running at highway speeds can overheat to the point of fire within a few miles.

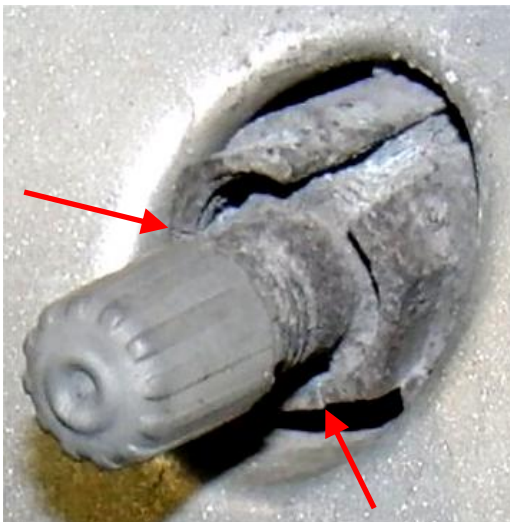
The stem nut on the left front wheel showed corrosion, but appeared to be intact. The stem nut on the left rear wheel was obviously split, with what appeared to be aluminum oxide and road grime entrained in the opening, as shown in Figure 5. It also had additional cracks visible at the outer surface. The stem nut on the right rear wheel exhibited a crack at the outer edge, but was not opened as much, as shown in Figure 6.

Figure 5: Split stem nut on left rear.

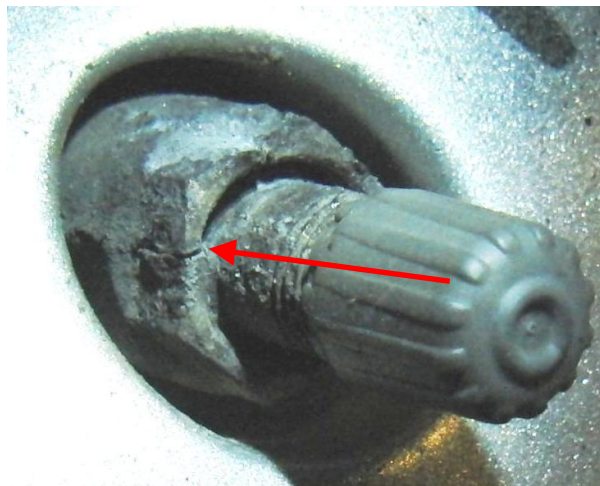
Figure 6: Fracture on right rear stem nut
