TPMS AND TIRE FIRE: A Cautionary Tale (April 2012)

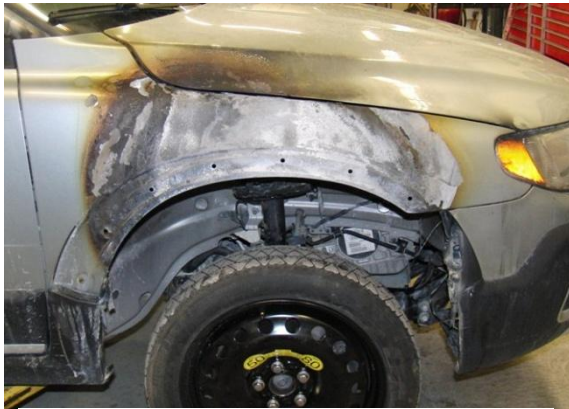
The front right fender burn pattern was consistent with the tire having burned in place while stopped, as shown in Figure 3. The fire was successfully extinguished and the mini-spare was mounted on the front right wheel position allowing the car to be driven

Figure 3: Burn pattern on fender.
