## TPMS AND THE TIRE FIRE: A Cautionary Tale (April 2012)

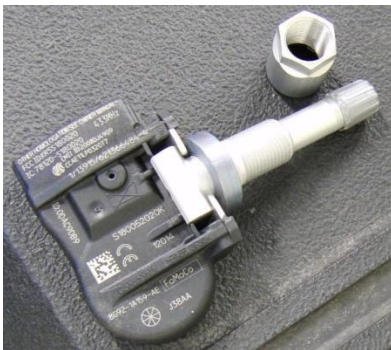
Figure 1: Exemplar TPMS unit, with stem nut removed.

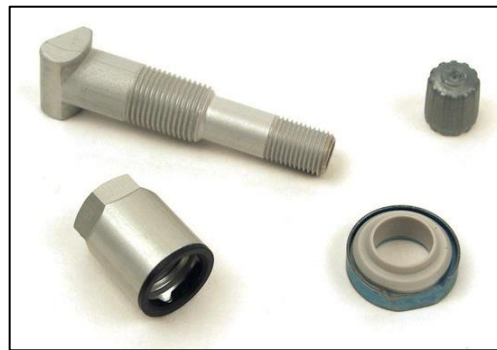
Figure 2: Typical TPMS service kit components.

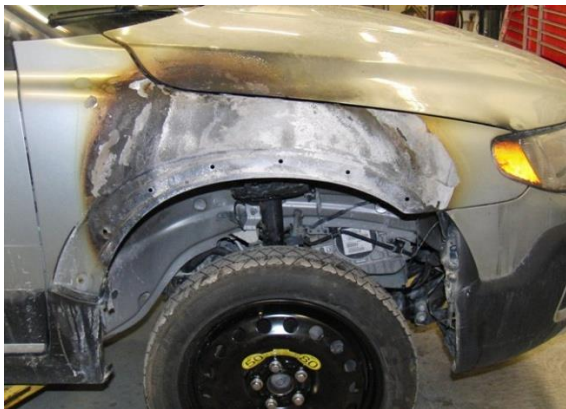
The front right fender burn pattern was consistent with the tire having burned in place while stopped, as shown in Figure 3. The fire was successfully extinguished and the mini-spare was mounted on the front right wheel position allowing the car to be driven

**Figure 3: Burn pattern on fender.**

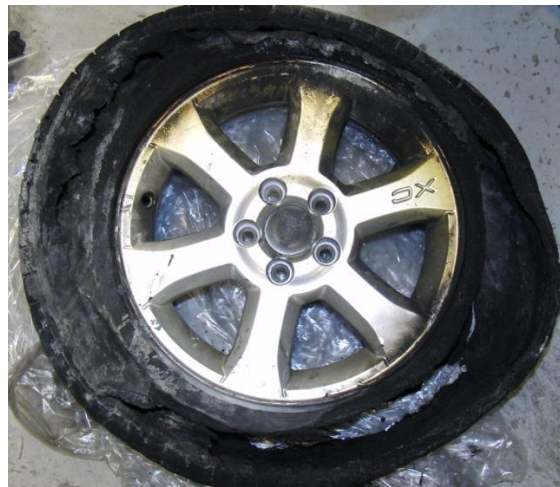
around the lot and into the service bay. The newly installed but now damaged tire is shown in Figure 4, still mounted to the wheel. Taking the valve stem hole as 12-o'clock, the tire outer sidewall was still intact between about 10-o'clock and 12-o'clock. The inner sidewall had a somewhat longer section still intact. In these areas, the sidewall showed both directional rubber tearing and grinding which had obliterated portions of the raised lettering. This damage is consistent with having been driven at severely low or zero air pressure. The TPMS unit was missing completely. The aluminum wheel displayed no slumping or heat deformation which would be expected to completely destroy the TPMS unit or allow it to separate from the wheel.

**Figure 4: Damaged wheel and tire.**

The missing TPMS unit was not located in an area where fire could have melted the metallic components. The wheel surface near the valve stem hole was sooted. This indicates that the TPMS sensor was not lost simply as a result of the fire, but rather came out for other reasons, and was not in place during at least most of the conflagration.

A cracked stem nut will eventually cease to retain the valve stem and the attached TPMS unit, allowing an air leak. A completely fractured nut will eventually fall off. The TPMS sensor would then be loose inside the wheel. The best explanation for the front right TPMS unit missing now is that it fell out of the damaged wheel either while driving after it came out, or during recovery. The car lived in northern New England, where road-salt is common in winter, which may have played a role in this event.

Protracted operation at low air pressure, most likely in the presence of the dashboard warning, allowed the tire to overheat enough to ignite the internal components. This conflagration erupted once the car was stopped.

The “take-away” from this story is that TPMS sensors should be inspected and serviced as recommended by the manufacturer, even though they are mostly made of metallic components. Also, low-pressure tires running at highway speeds can overheat to the point of fire within a few miles.

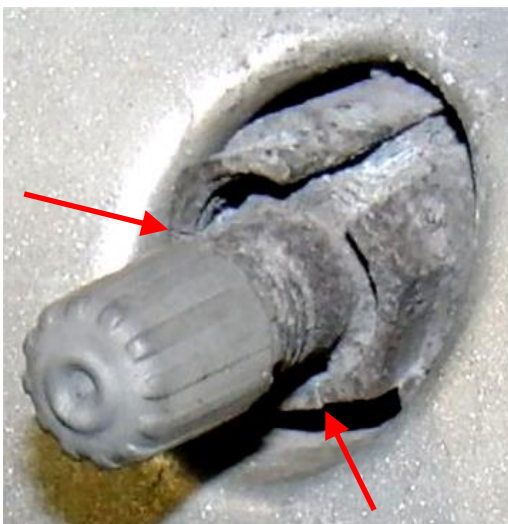
The stem nut on the left front wheel showed corrosion, but appeared to be intact. The stem nut on the left rear wheel was obviously split, with what appeared to be aluminum oxide and road grime entrained in the opening, as shown in Figure 5. It also had additional cracks visible at the outer surface. The stem nut on the right rear wheel exhibited a crack at the outer edge, but was not opened as much, as shown in Figure 6.

**Figure 5: Split stem nut on left rear.**

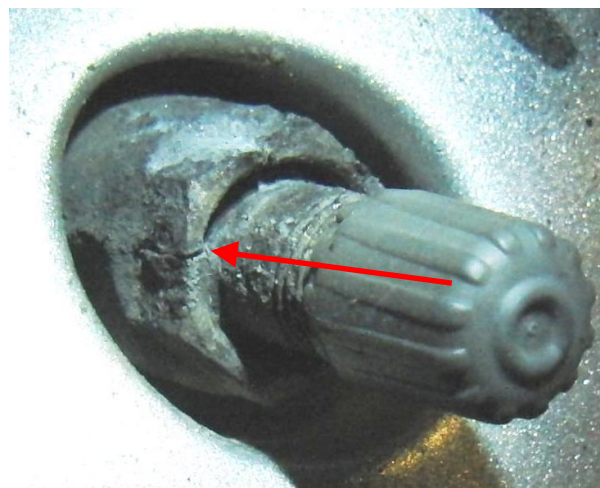
**Figure 6: Fracture on right rear stem nut**
